Staff Report

Memo Date: January 14, 2025
To: Utility Commission
From: Kyela O'Loughlin, P.E., Public Works and Utilities Director
Subject: Vilas Road Sanitary Sewer Dip and Replacement

Inspection report

Section Pictures - 5/21/2025 - 772-771

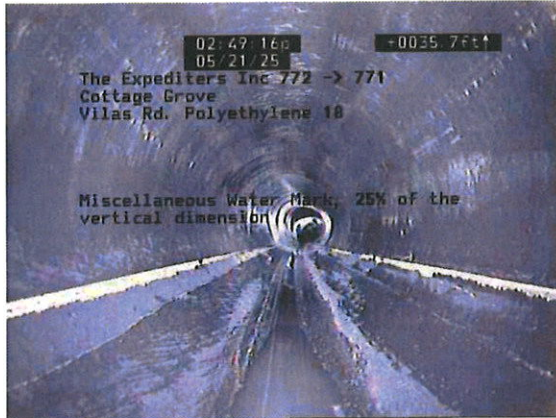
772-771_5344c5a6-e20b-4afd-b8b7-55fbc94b08dd_20250521_152145_952.jpg, 00:02:04, 35.70ft
 Miscellaneous Water Mark, 25% of the vertical dimension

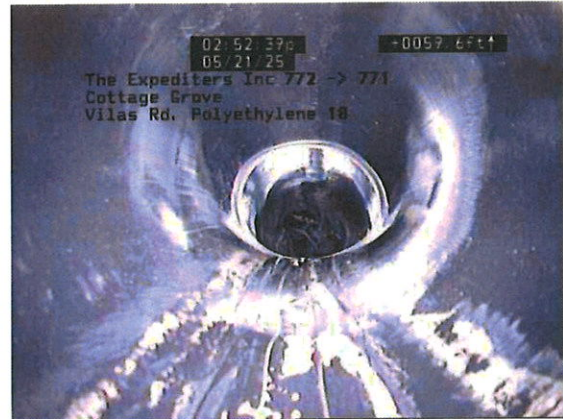
772-771_f7db0c77-7273-49a5-af2d-37f1addcbb67_20250521_152509_136.jpg, 00:02:37, 59.60ft
 Deformed Flexible Elliptical, 10%

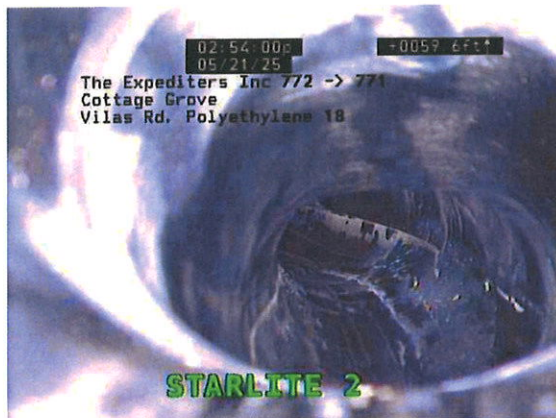
During the fall sanitary sewer televising this year, it was determined that a sanitary sewer pipe installed in 2020 under Vilas Road was not installed properly. It appears it was horizontally directionally drilled from the televising video and has a 60-foot sag that is holding water from the cleaning. Additionally, the directional drilling of the pipe does not appear to have the pipe straight, instead at a curvature. The televising report and still pictures can be found attached.

772-771_db0cff94-629b-4344-87d7-e5554e255330_20250521_152629_259.jpg, 00:03:02, 59.60ft
 Miscellaneous Survey Abandoned / Pipe Bends Down/Sag

Staff recommend moving forward with the proposal from Gerke Excavating for \$148,968.21 which includes all their proposed work except for the optional pavement markings, which Public Works staff will complete inhouse.

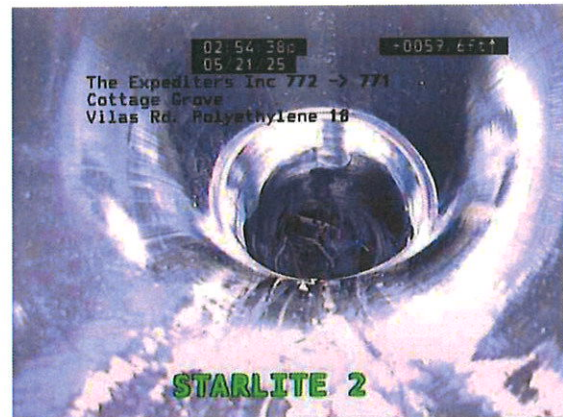
772-771_77cb5596-bd27-4455-8be5-f68d992f2f59_20250521_152707_760.jpg, 00:03:02, 59.60ft
 Miscellaneous Survey Abandoned / Pipe Bends Down/Sag
