**VILLAGE OF COTTAGE GROVE
PARKS, RECREATION AND FORESTRY DEPARTMENT
ACCESS AUDIT OF FACILITIES & PROPERTY**

VILLAGE OF COTTAGE GROVE
PARKS, RECREATION AND FORESTRY DEPARTMENT
ACCESS AUDIT OF FACILITIES & PROPERTY

MSA's team of professional planners and architects conducted accessibility audits of 11 village parks and Village Hall during Summer of 2017. An audit report for each park (refer to Section III) was developed including the following information:

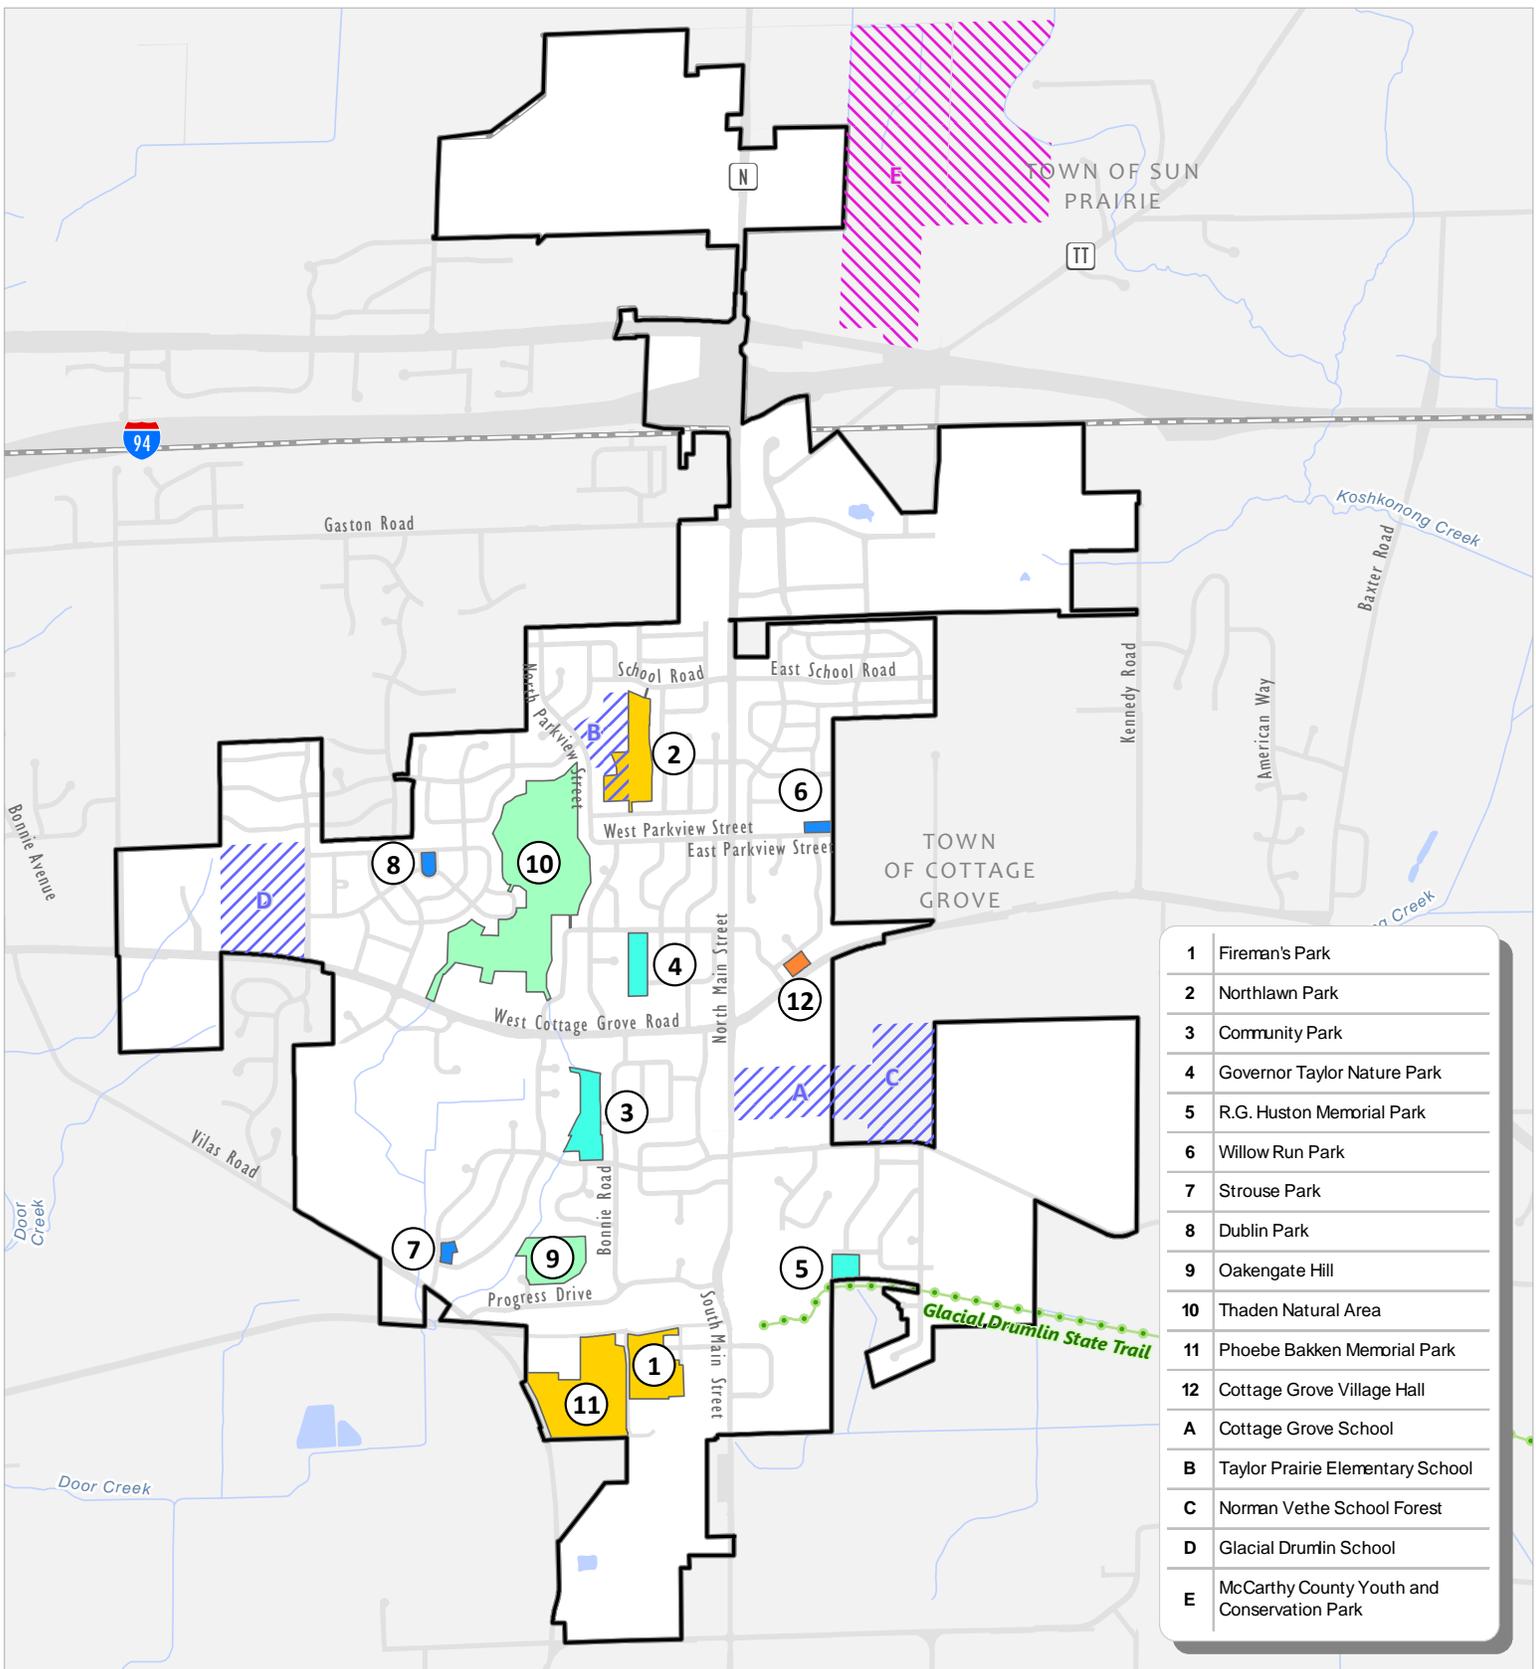
Existing Park Facilities

Cottage Grove Parks ADA Study

Village of Cottage Grove
Dane County, WI
